Inspection #: 2012-7943

Inspection Date: December 9 2020 9:00 AM

Property Address: 277 Patten Circle, Albrightsville, PA 18210

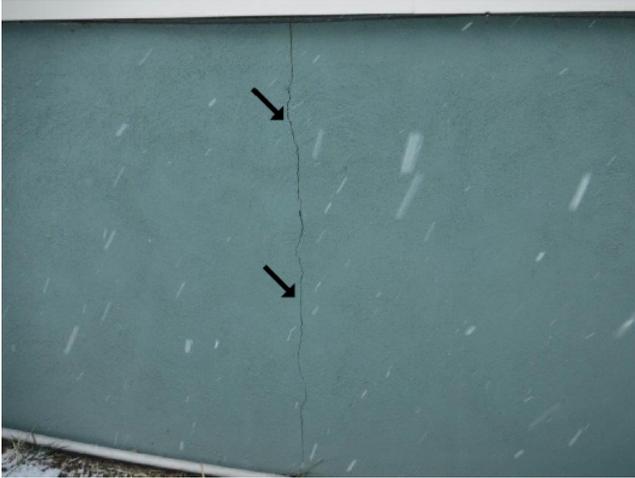
103 Exposed Foundation

[Minor \(hairline\) cracks at rear](#) | Suggest Buyer caulk cracks to prevent moisture penetration

Crack at foundation

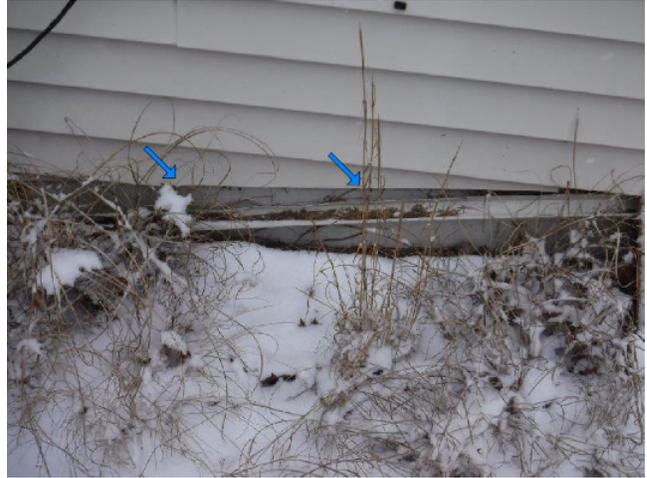
104 Siding

Loose siding and "J" Channel

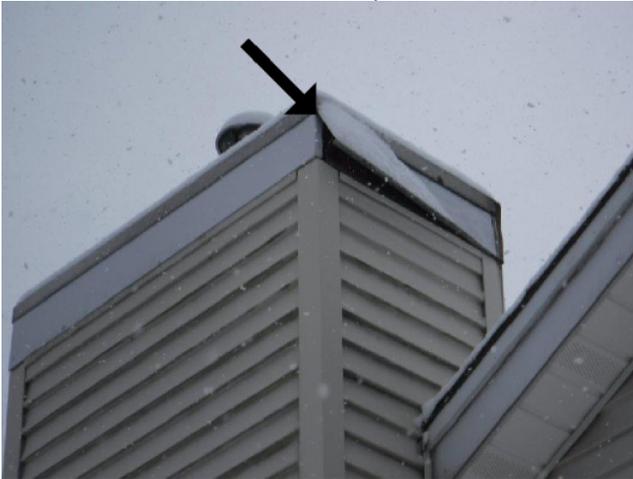
206C Visual components

Loose trim

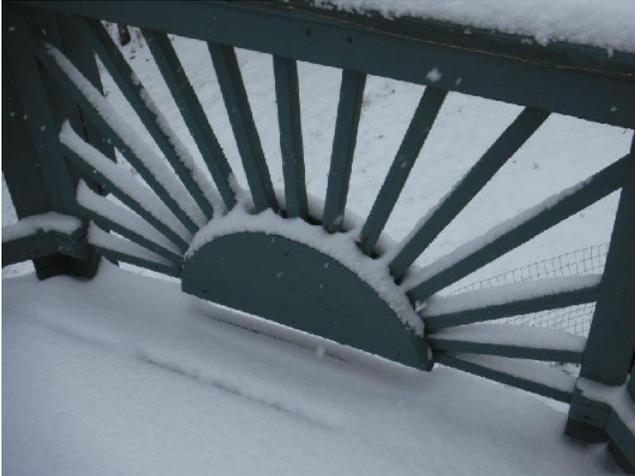
404D Railing Around Deck

Ornamental design / ladder effect

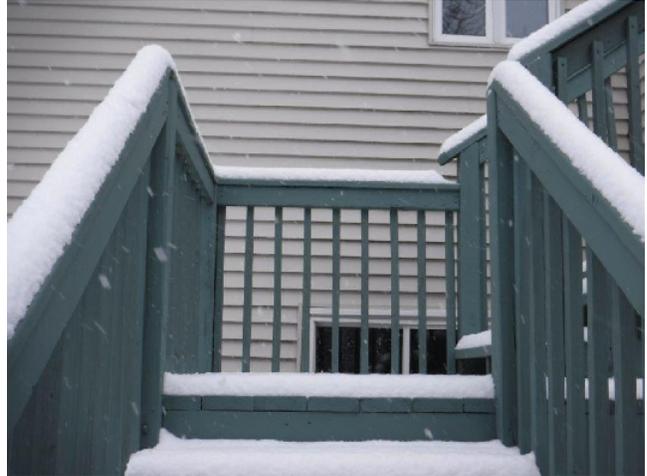
405D Stairs

Missing a graspable rail

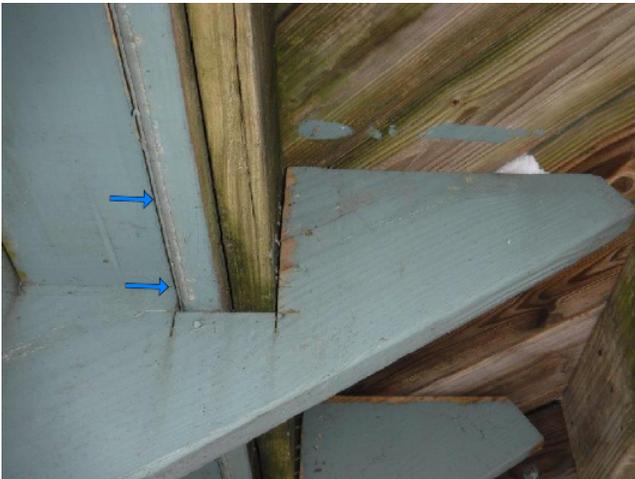
405D Stairs 📷:	<p>NO/grippable/rail</p> <p>Improper connection between stair stringers and deck connection. This connection can fail</p> <p>Suggest qualified contractor review, repair, replace as necessary. (All highlighted areas)</p>
406D Electrical Fixtures/Outlets:	Serviceable Light fixture Weather cover Operable GFCI outlet noted for safety.
407D Comments:	All or portions of this deck appears to be homeowner built. Reasonable, customary and acceptable protocols may have not been followed. A review by a qualified contractor is suggested.

The stringer connection to deck is not properly supported. This is poorly supported with minimal support.

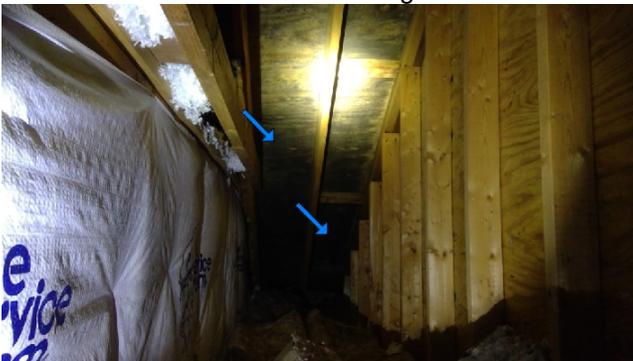
803A Sheathing

Blackened sheathing noted. It is a condition created after many years of condensation gathering at the roof sheathing affecting the tannins in the wood. Long standing moisture from various sources can contribute to this condition, lack of ventilation, etc. This condition can cause organic growth / discoloration while some areas may just appear stained.

Black sheathing

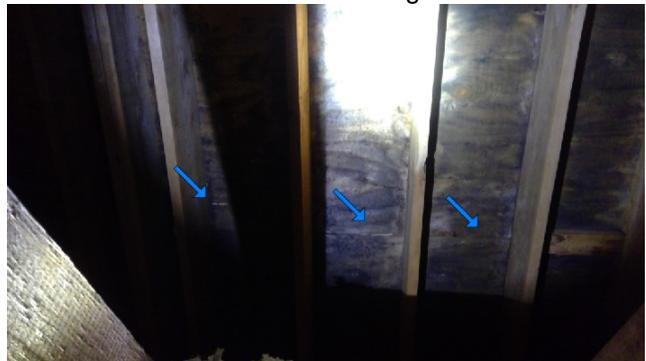
803A Sheathing

Black sheathing

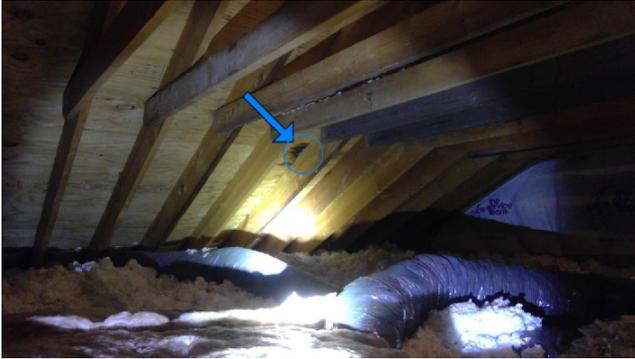
803A Sheathing

Moisture stains noted. Inspector is unable to determine if active or not. It is often not possible to determine if stains are a result of active leakage or other water problems previously corrected. Further review necessary to establish a conclusion.

Moisture stain

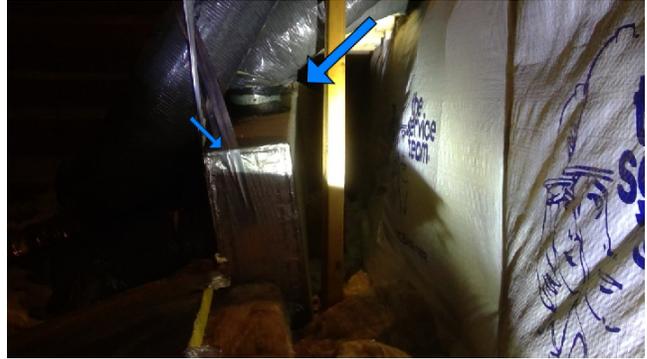
810A HVAC Ducts

Section of separated duct work / improperly supported

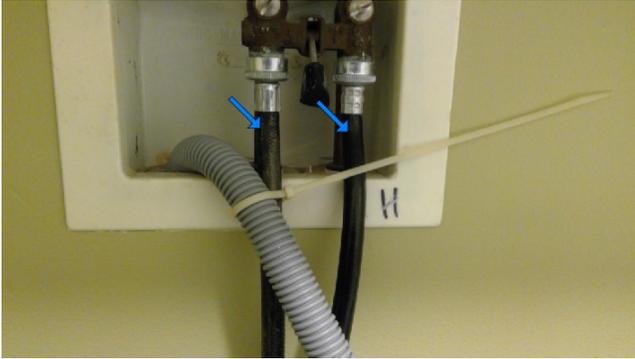
1009 Washer Hook-Up

: [Rubber hose noted. Suggest buyer upgrade to metal-jacketed hoses. Rubber hoses have the potential to fail and cause extensive damage.](#)

Rubber hoses - suggest buyer upgrade to metal braided style

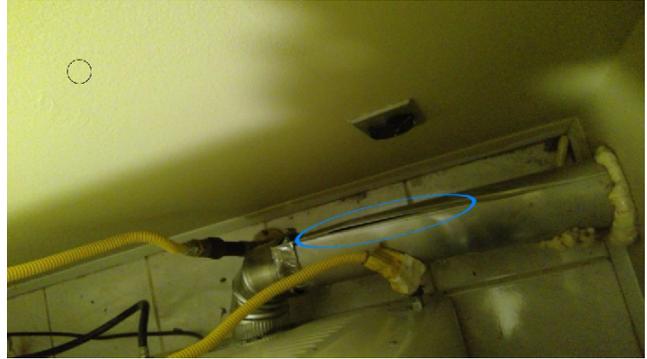
1011 Dryer Hook-Up

: [Gas | Gas valve present | Metal vent | Dryer vent split | Suggest qualified contractor review, repair, replace as necessary. \(All highlighted areas\)](#)

Dryer vent split

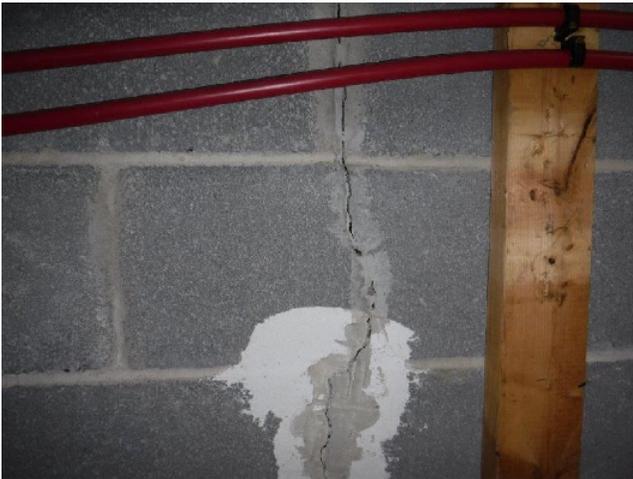
1104 Walls

Foundation crack - suggest caulking

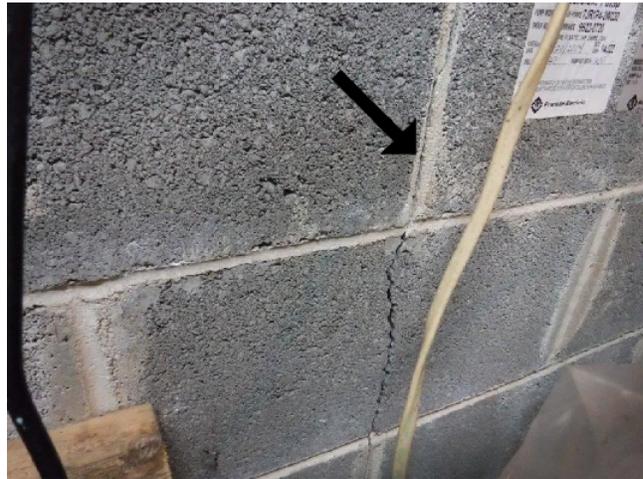
1104 Walls

Foundation crack - suggest caulking

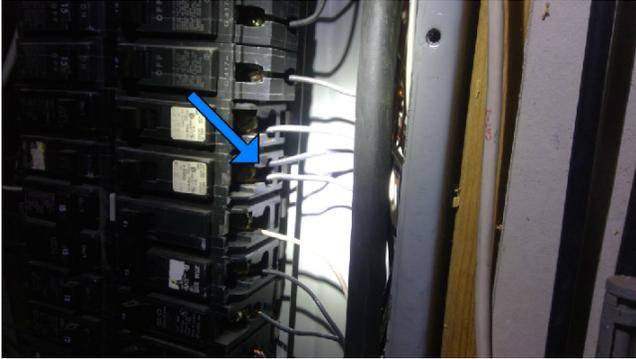
106E Main Panel Comments

Double tapped breaker - 110-volt double-lugged circuits observed. Double-lugged means that multiple wires are served by a single breaker. Some panelmanufactures allow this connection, nonetheless we are not able to determine if the total rated amperage is exceeded.

Double tapped breaker

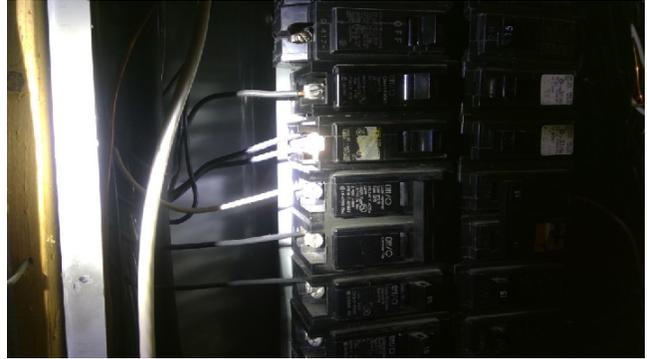
106E Main Panel Comments

Double tapped breaker

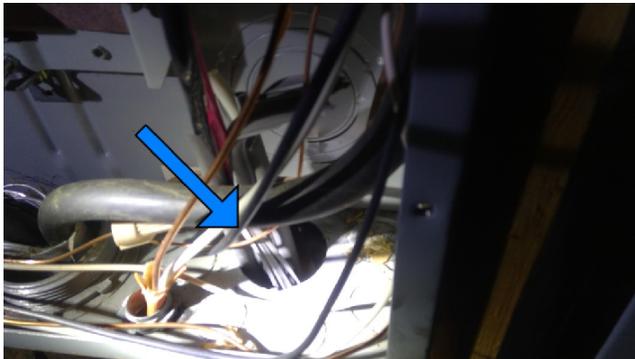
107E Additional Main Panel Comments

[Knock-outs have been made in the face of the electric service panel, which can permit access to live electrical components. This is a safety hazard.](#)

Knock out missing

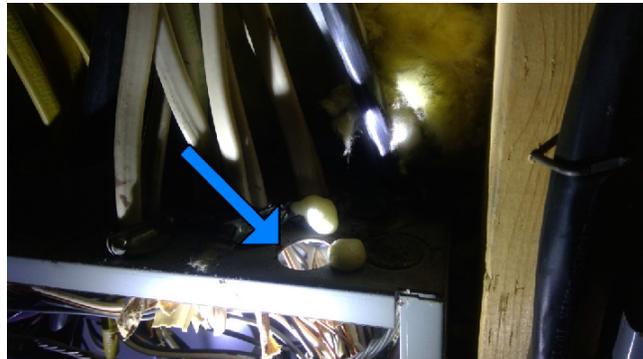
107E Additional Main Panel Comments

Knock out missing

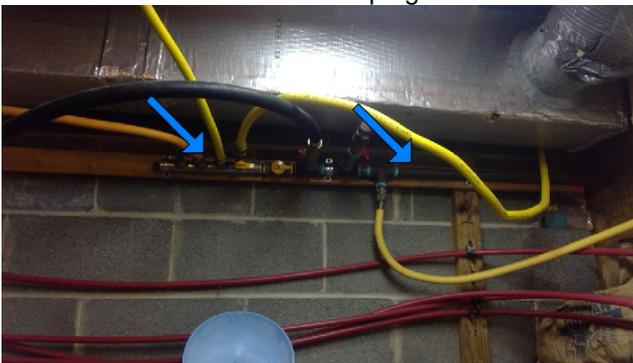
209P Gas Piping

CSST gas piping not bonded

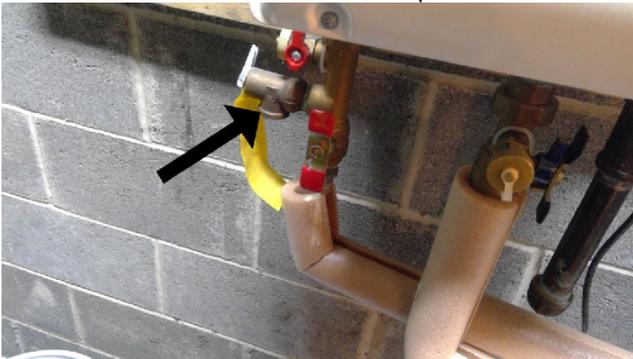
304WH TPR valve / components

Missing TPR extension pipe

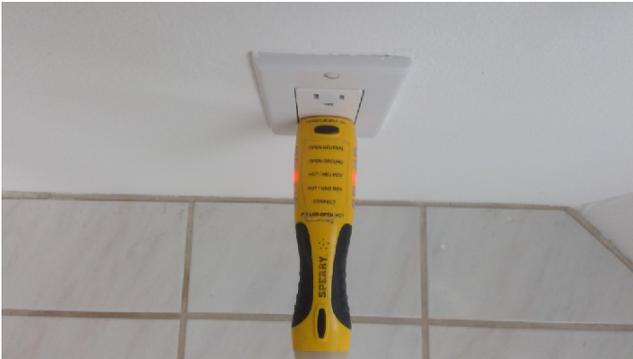
1307 Electrical

Reversed polarity

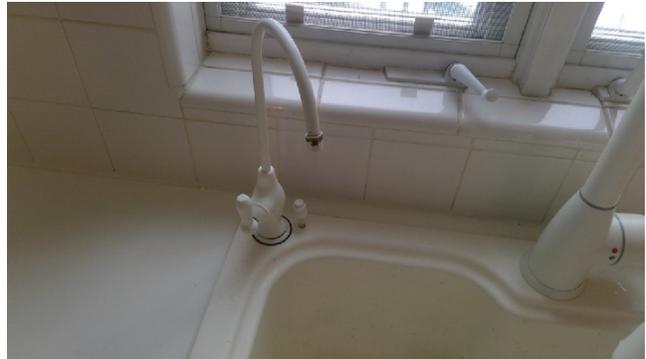
1309 Faucets

Filtered water system - Off - not working

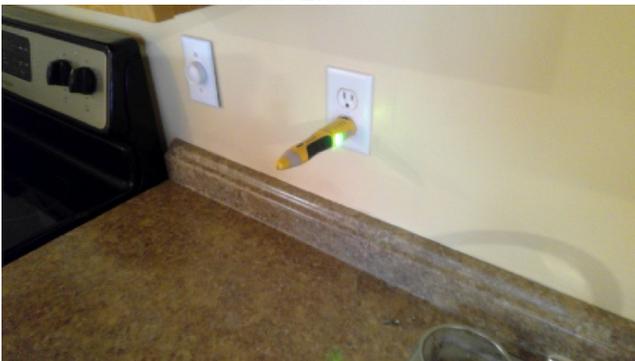
1307 Electrical

No GFCI

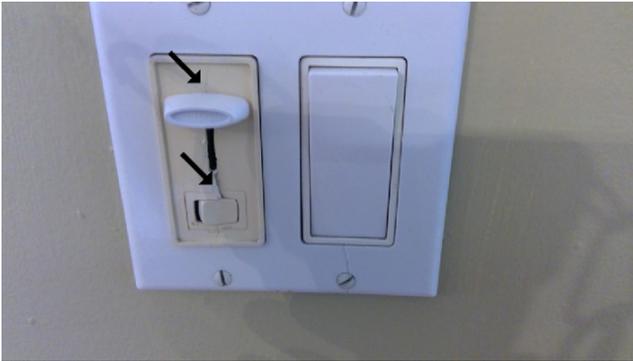
1405 Electrical

Cracked switch

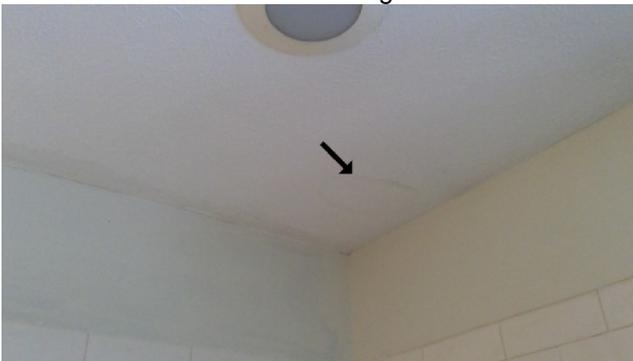
2403 Ceiling

Moisture stain

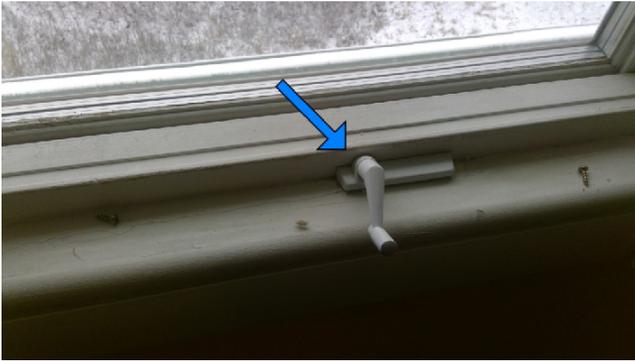
2505 Windows

Inoperable crank mechanism

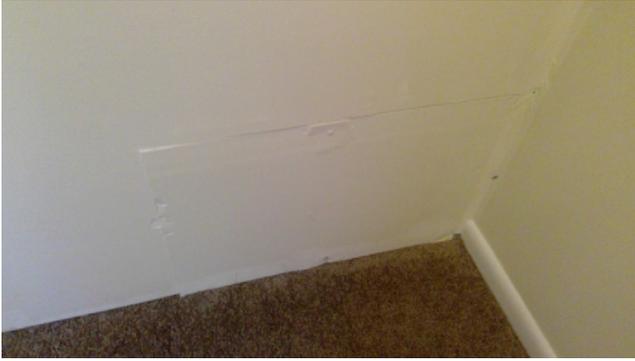
2502 Walls

Patched area

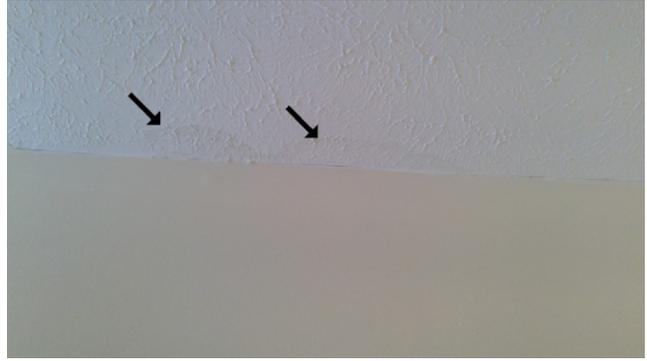
2502 Walls

Moisture stains

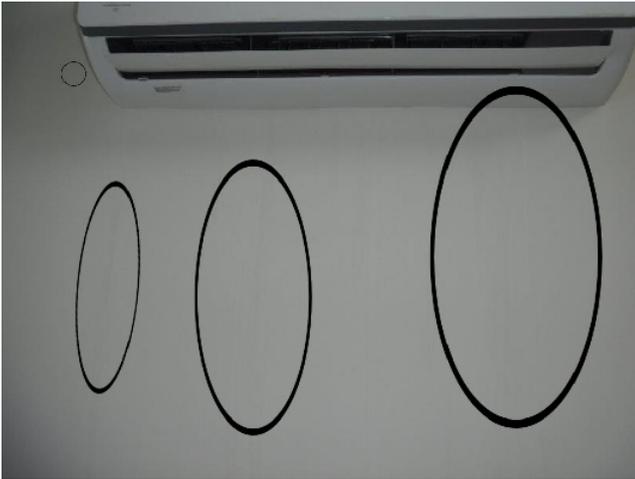
2502 Walls

Moisture staining below ductless system -difficult to see in picture

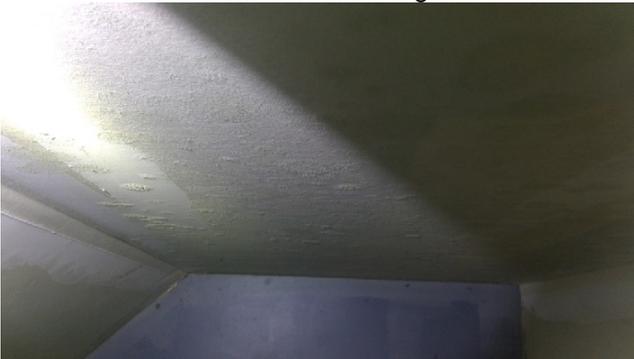
2702 Walls/Railing

:	Serviceable Wallboard Organic material / discoloration noted. Suggest qualified contractor review / treat as necessary. Suggest qualified contractor review, repair, replace as necessary. (All highlighted areas)
2703 Ceiling:	Serviceable Open Joists
2704 Doors:	Serviceable Pivot
2705 Windows:	Not applicable
2706 Electrical:	Serviceable Overhead / wall light
2707 Comments:	None

Discoloration / organic growth material
