Inspection #: 2108-7323

Inspection Date: August 15 2021 11:00 AM

Property Address: 6186 Lakeview Drive, Pocono Pines, PA 18350

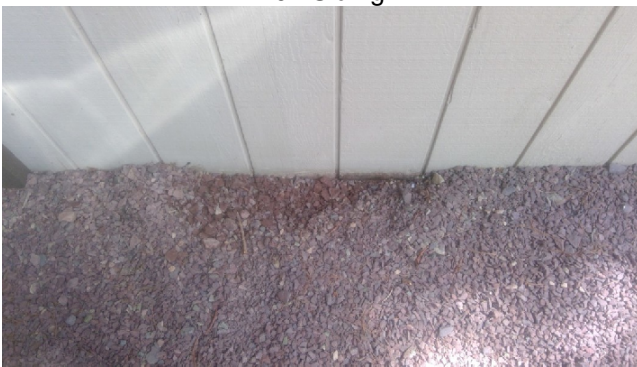
104 Siding

Siding is within 6 inches of grade at at front. Suggest re-grading to prevent siding / soil contact, and to help reduce the potential for wood substrate deterioration and wood pest infestation.

Siding / soil contact

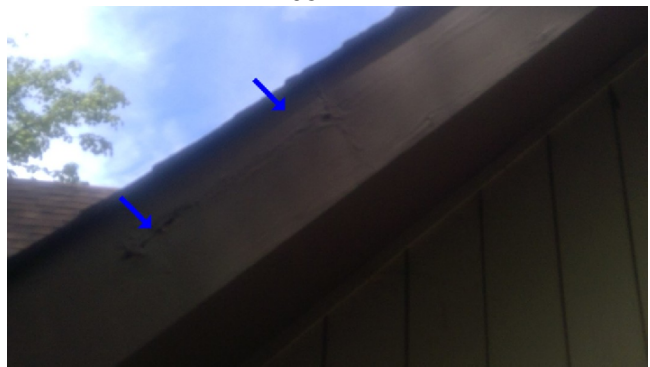
105 Trim

Dry rot at trim at left side shed, around chimney, rear rake boards

Dry rot at rake trim

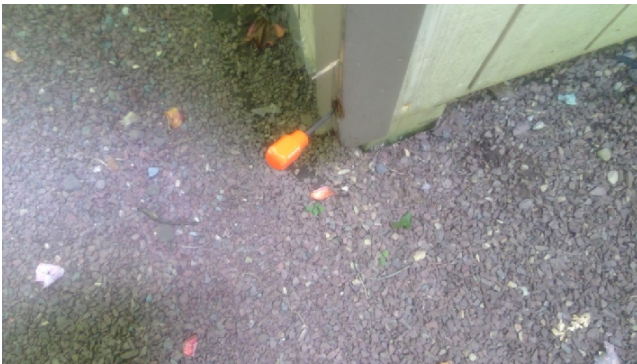
105 Trim

Dry rot by left side shed

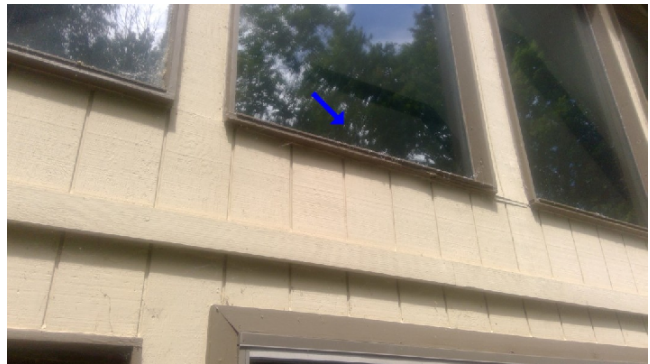
107 Windows and Frames

: Serviceable | Thermopane | Dry rot noted at rear fixed window

Dry rot at window

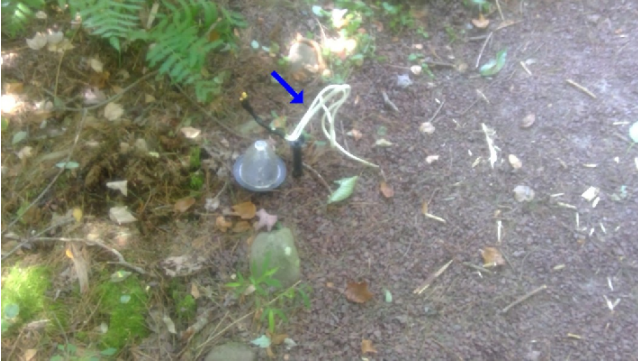
108 Electrical Fixtures/Outlets

Exposed wiring on walking path to lake also not rated for direct bury

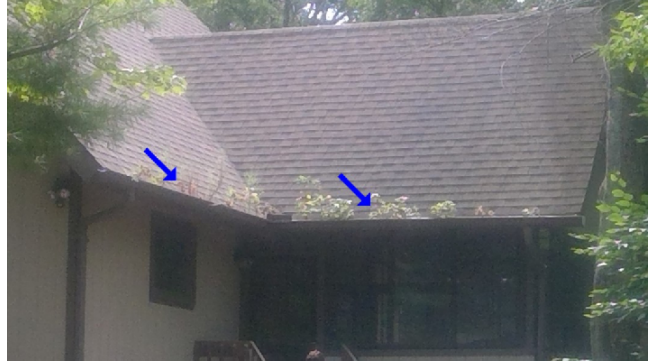
109 Gutters and Leaders

The gutters were noted to be filled with seasonal debris. Regular maintenance, consisting of the removal of leaves and debris, will prevent damage to gutters and fascia systems.

Gutters with debris

Suggest gutter system maintenance be performed. This includes cleaning, re securing, re attaching any loose or missing component, preventive maintenance and any other means necessary to keep water properly flowing and diverted away from the structure.

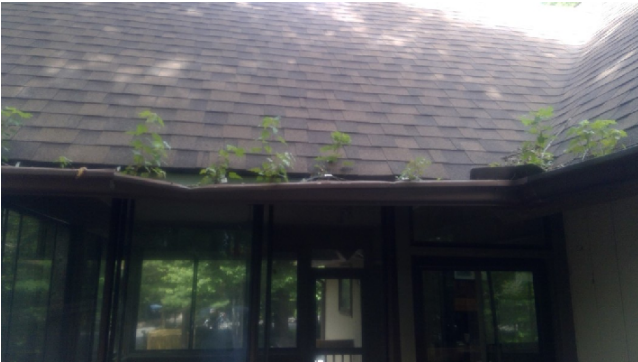
109 Gutters and Leaders

Aluminum | Damaged at rear

Gutters with debris also damaged

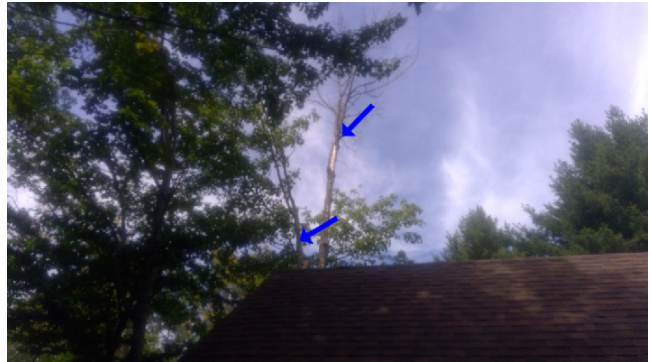
119 Miscellaneous

Standing dead trees noted in close proximity to the home front and rear - suggest removal. (Safety issue)

Standing dead trees at front

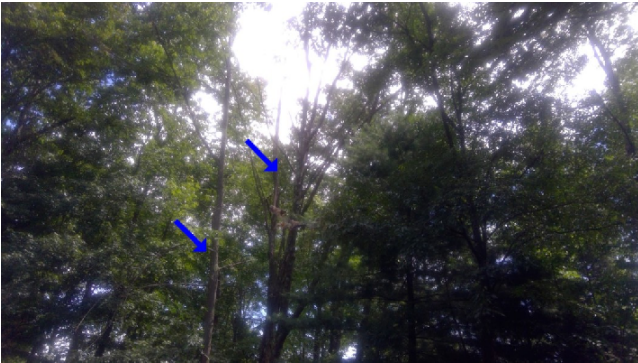
119 Miscellaneous

Standing dead at rear

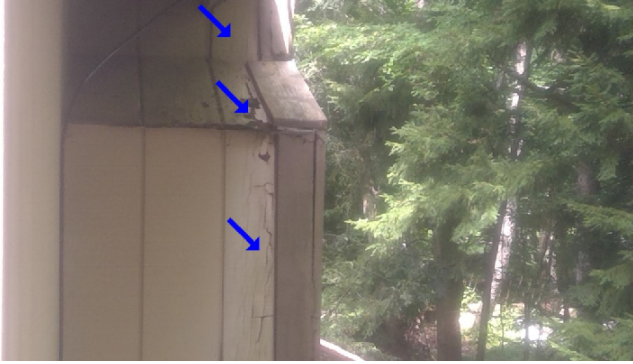
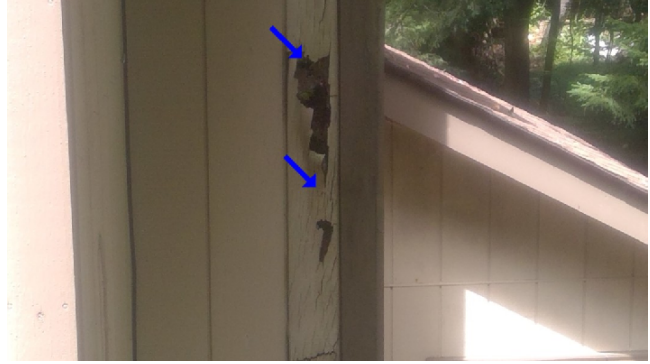
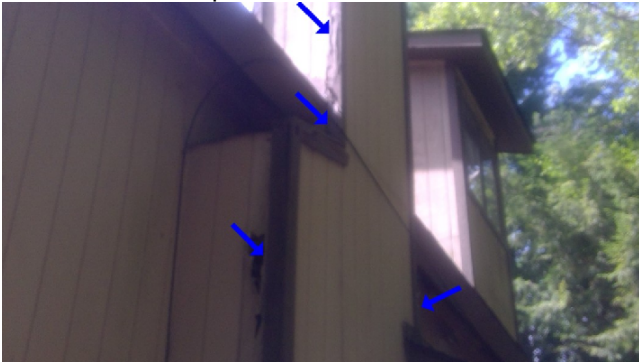
: T1-11 / wood siding | [Dry rot noted through out](#)

Dry rot

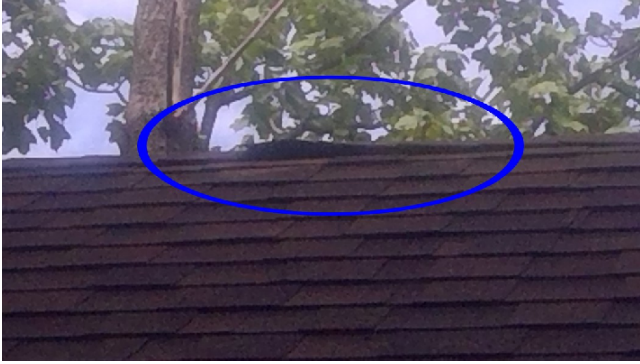
304R Condition

Lifting shingle

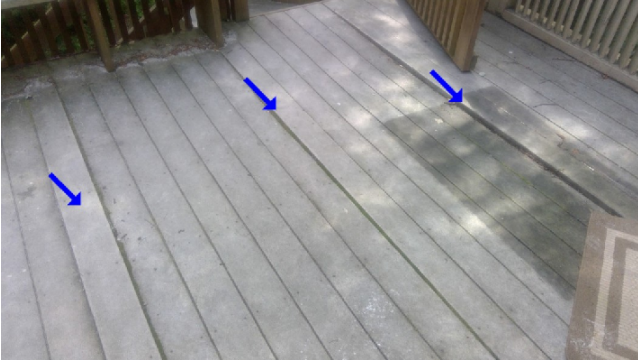
403D Deck/Slab

Lifting sections noted with no access below to see the root cause

Lifting deck boards

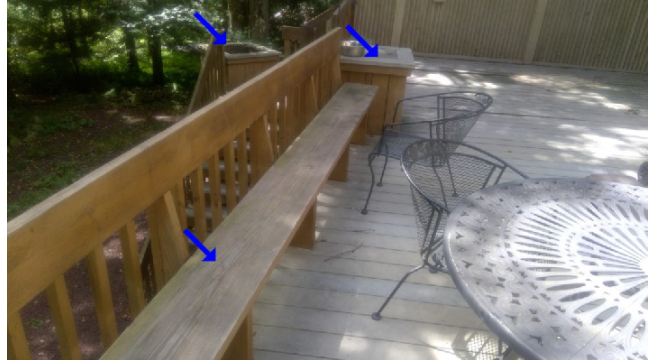
404D Railing Around Deck

SAFETY ISSUE - The built-in seating and built in planters presents a falling / safety hazard for deck occupants.

Built in seating hazard / planter safety concern

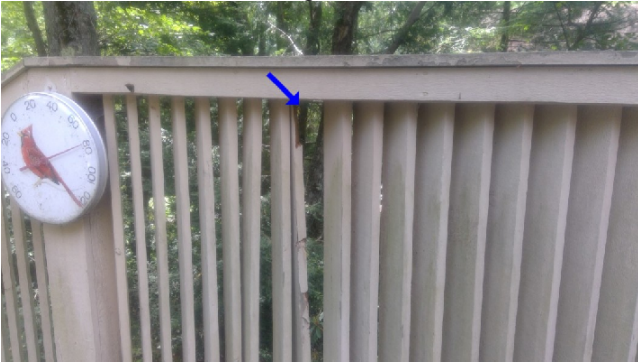
404D Railing Around Deck

Damaged section at privacy fence

loose board on privacy fence

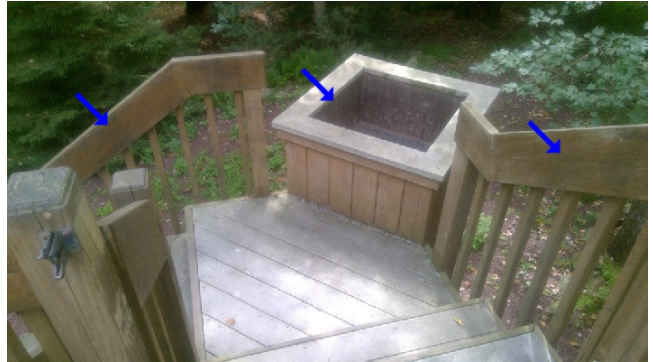
405D Stairs

Railing noted but without a grippable shape. All railings installed should have a grippable shape for safety.

Planter also noted at stairwell - hazard

Planter hazard - missing proper graspable handrail

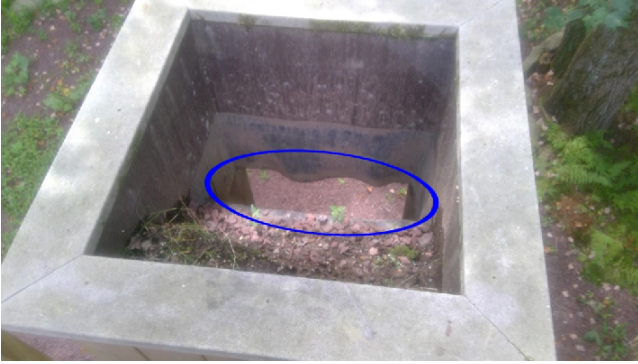
405D Stairs

Planter rotted - hazard

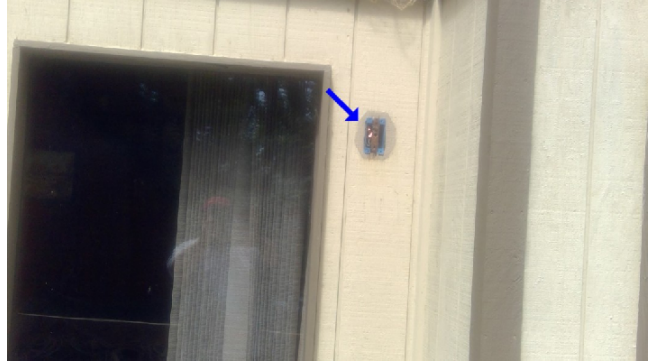
406D Electrical Fixtures/Outlets

SAFETY ISSUE - Exposed live wiring was noted. Whenever an electrical wire is cut and re-connected, the splice should be encased in a covered junction box to prevent shocks and separations of the splice.

Exposed live electrical wires

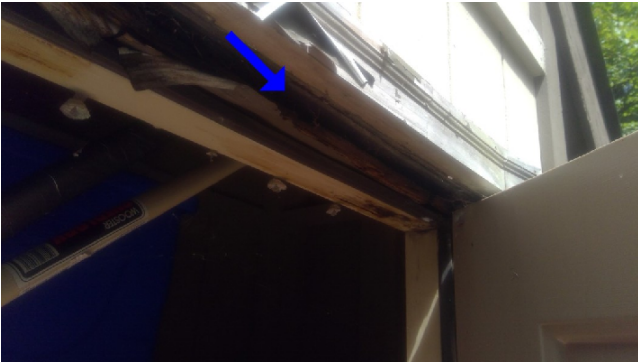
407D Comments

Dry rot around door at deck closet

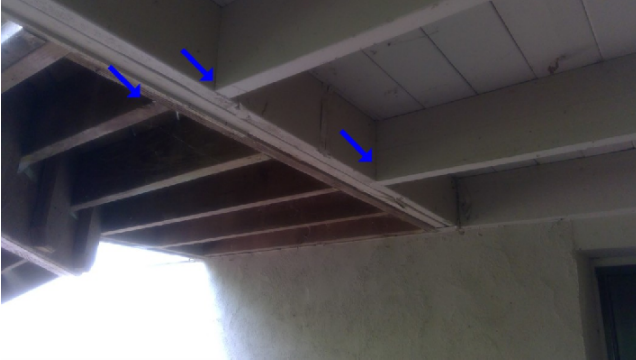
402D Structure

Missing hangers

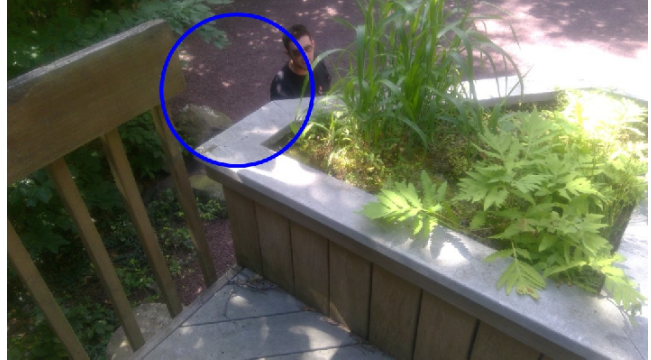
404D Railing Around Deck

Rails missing / planter box issue

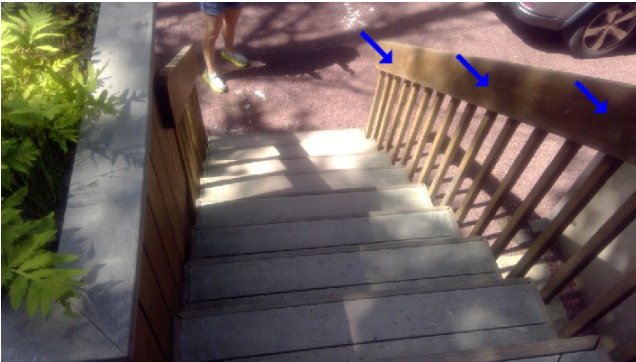
405D Stairs

Missing proper graspable rail

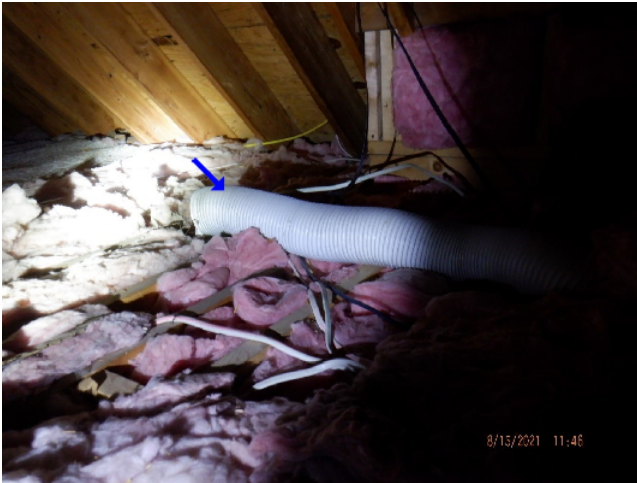
808A Ventilation

Bathroom exhaust vents to attic. Suggest re-routing to the exterior to prevent in-house moisture build-up.

Bathroom fan vents to attic

Suggest qualified contractor review, repair, replace as necessary.

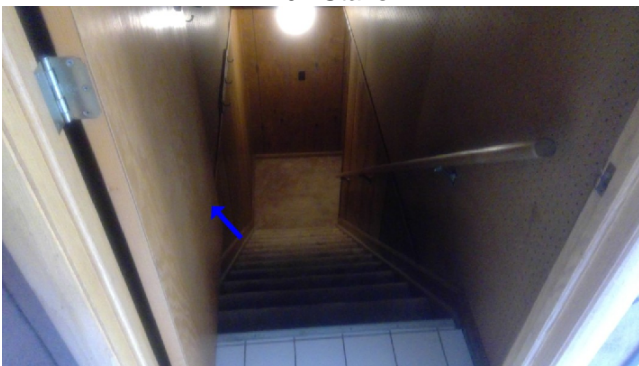
1102 Stairs

[Door from kitchen opens over stairs and not into the room - fall hazard](#)

Door swings over the stairwell

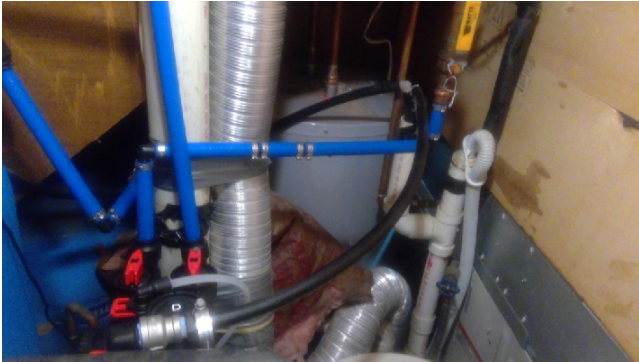
303WH Water Heater Located At

Limited view to components under stairs

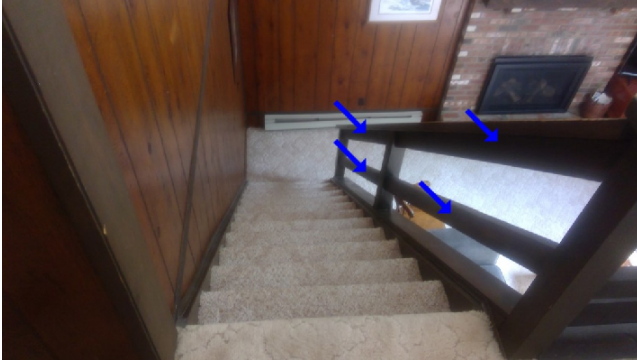
1201 Stairs

Ladder effect - missing graspable rail

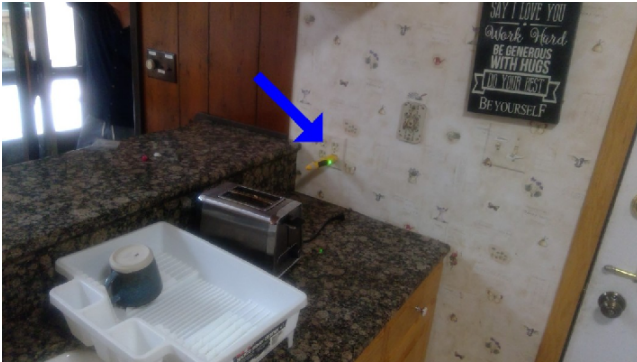
1307 Electrical

Missing a GFCI outlet

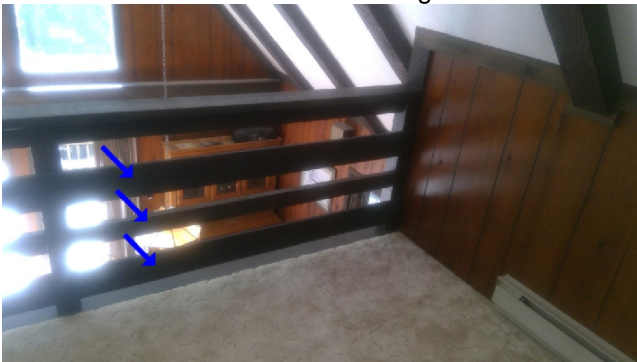
1602 Walls/Railing

Ladder effect

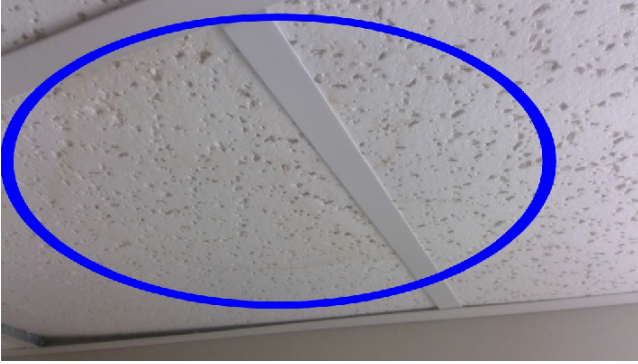
2403 Ceiling

Moisture stain

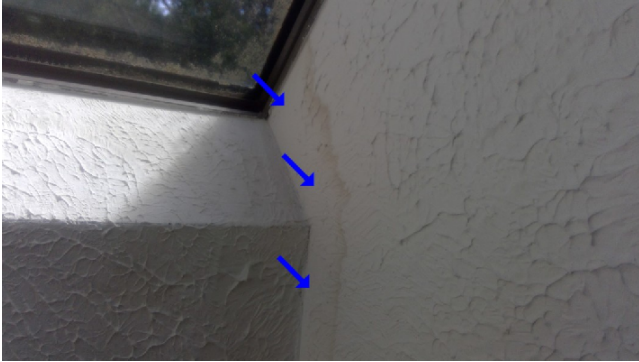
2505 Windows

Staining around skylights

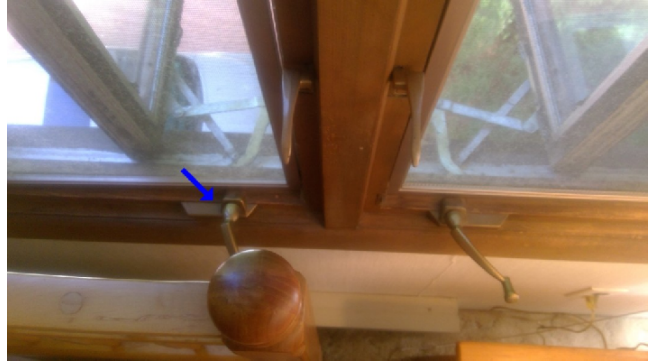
2505 Windows

Inoperable crank

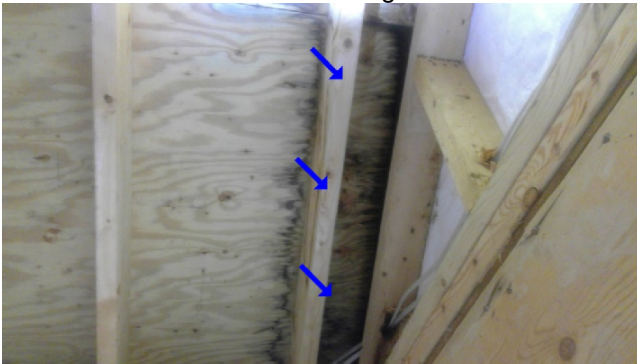
2703 Ceiling

Moisture staining / dry at time of inspection
